Thompsonville Fire Department

**Thompsonville Fire Department
11 Pearl Street
Enfield, Connecticut 06082-3501
Phone: 860-745-3365 Fax - 860-745-1492
Connecticut State Fire Safety Code
Abatement Order of Fire/Life Safety Hazards**

Thompsonville Fire Department The Site

Thompsonville Fire Department The Facility

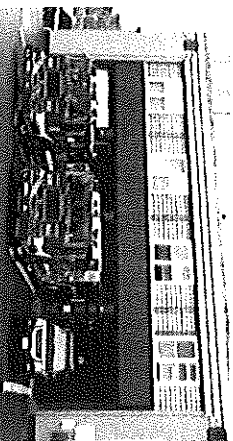
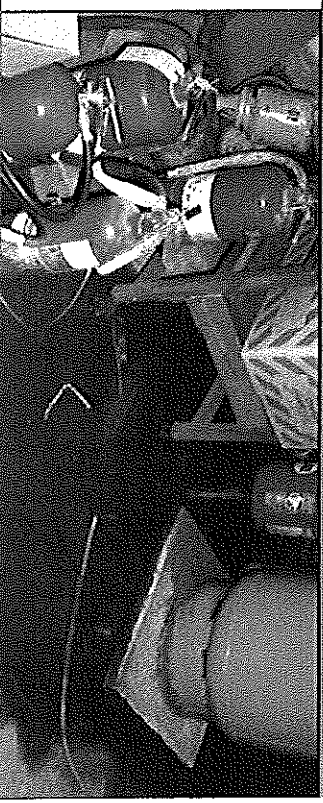
In addition to moisture in basement, there have been significant floods. Most recently in 2003: 3' – 4' of water in the basement. In 1955 floodwaters rose to the first floor.

Non-conformance with FEMA FA-168 and IBC

- History of flooding
- Relocation must be considered
- Upgraded structures are required in flood-prone areas

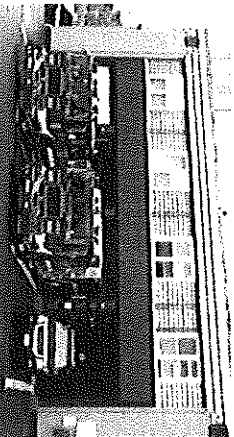
Moisture intrusion is
a constant problem
365 days/ year.

Non-conformance with FEMA FA-168 and OSHA

- Flood prone areas should be avoided
- Sick-building syndrome
- Water on floor areas is hazard for slipping

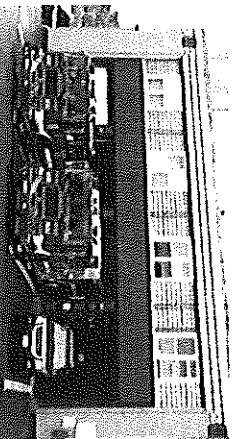
Water runs through
electrical service and
fixtures.

Non-conformance with NEC

- Electrocution hazard
- Disruption of service

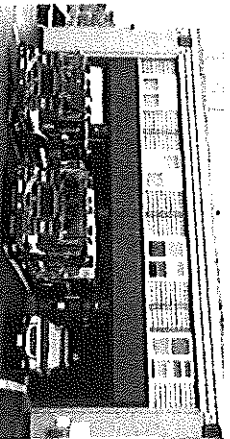
Exterior water damage
